This Service Bulletin is a supplement to the Service Manual Instrumentation, VNL, VNM, Group 38, PV776-TSP23762/1.

Instrumentation
VNL, VNM

Volvo Bulb Removal Tool

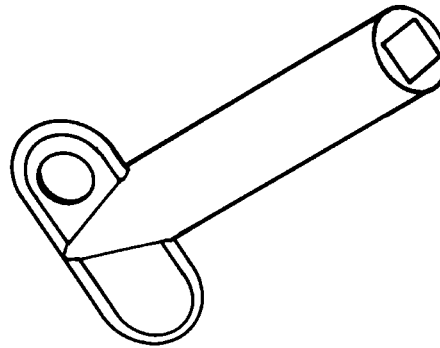
W3000642

P/N 1089953

In the Tools section of Service Manual *Instrumentation, VNL, VNM, PV776-TSP23762/1*, the bulb removal tool is incorrectly identified.

Use only the Volvo bulb removal tool, P/N 1089953, to remove bulbs, or damage to the cluster may occur.

The part number for the Volvo Bulb Removal tool should read 1089953. This is the only tool recommended for bulb replacement on the 1996 and 1996B Instrument clusters. Please note this correction on page 7 of your *Instrumentation, VNL, VNM Service Manual*.
