Service Manual Trucks

Group **884–500**

SRS Airbag, Safety Belts and Bunk Restraints

VN, VHD

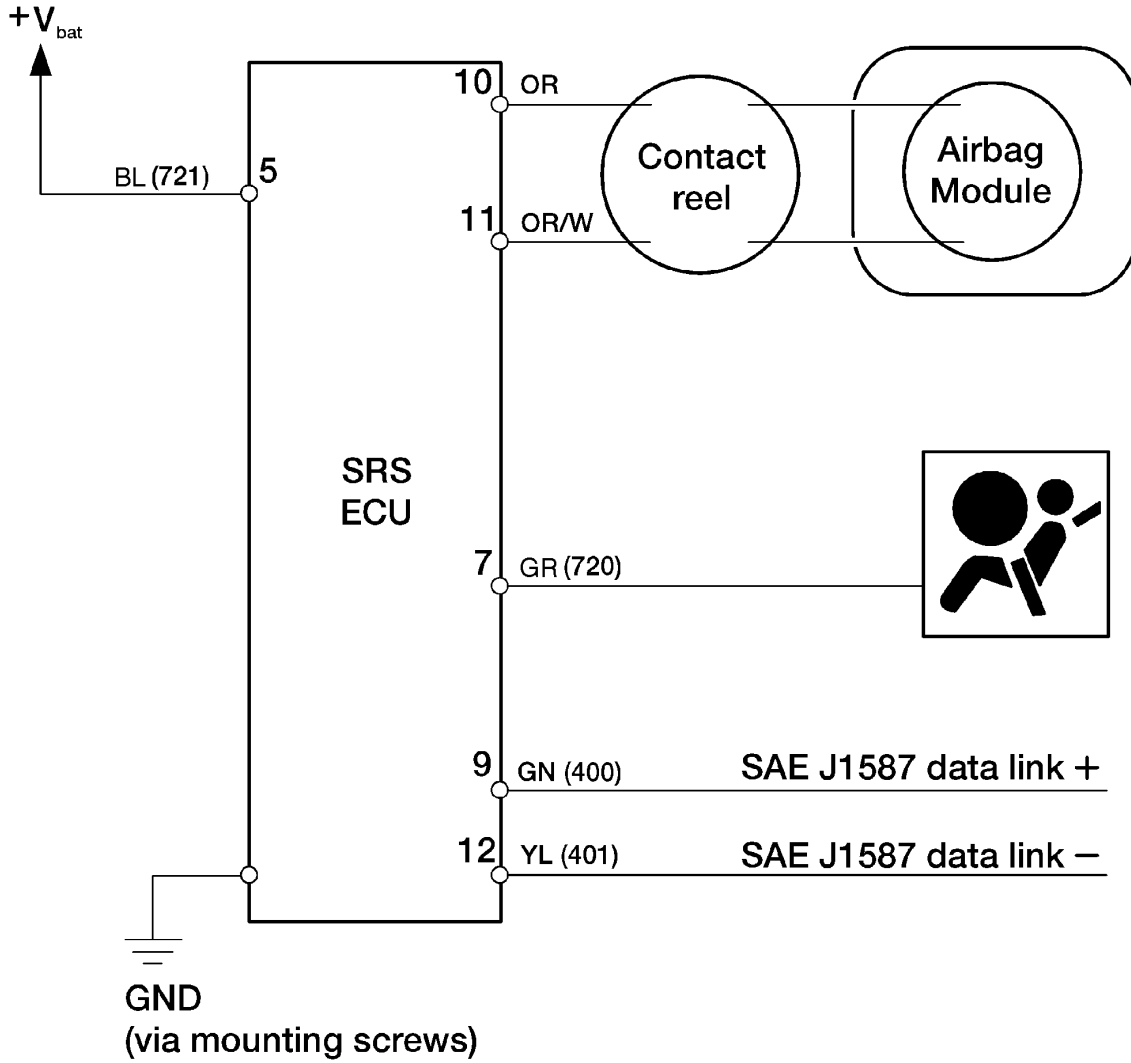
W8002903

Wiring Diagram (vehicles built prior to 3/99)

Note: Numbers in parentheses are circuit numbers printed on the wire insulation.

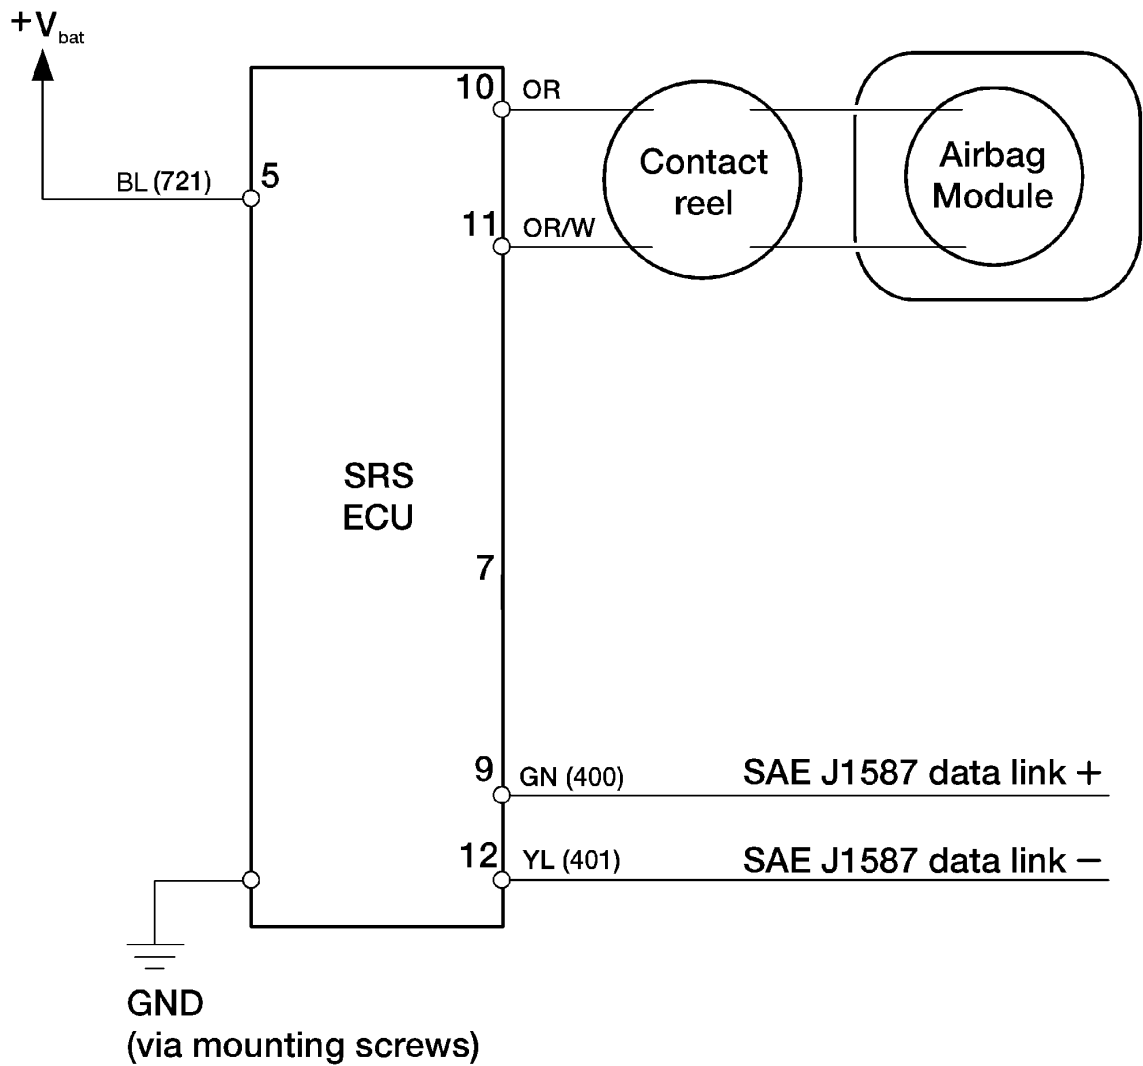
W8002904

Wiring Diagram (vehicles built from 3/99)

Note: Numbers in parentheses are circuit numbers printed on the wire insulation.

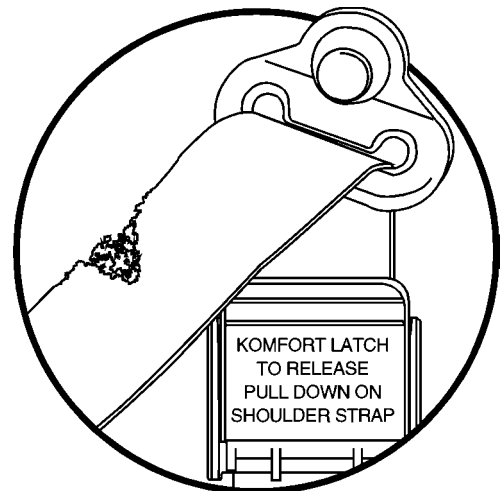
W8001405

The D-loop web guide is an area where almost constant movement of the safety belt webbing occurs because of the relative movement between the seat and the cab. Because of this constant movement this is an area where wear will often occur. The webbing must be closely examined to determine if there are any cuts, frays or extreme wear in the webbing. Cuts, frays or excessive wear indicate the need for replacement of the safety belt system.
